Subject: Monthly Progress Report No. 6
CH2M HILL/E&E Oversight of Remedial Action Activities
Enviro-Chem (ECC) Superfund Site, Zionsville, Indiana
WA No. 008-RXBF-0530, Contract No. 68-W6-0025

ECC RA Oversight Progress Report No. 6 (June 1998)

CH2M HILL Remedial Action (RA) Oversight Observation

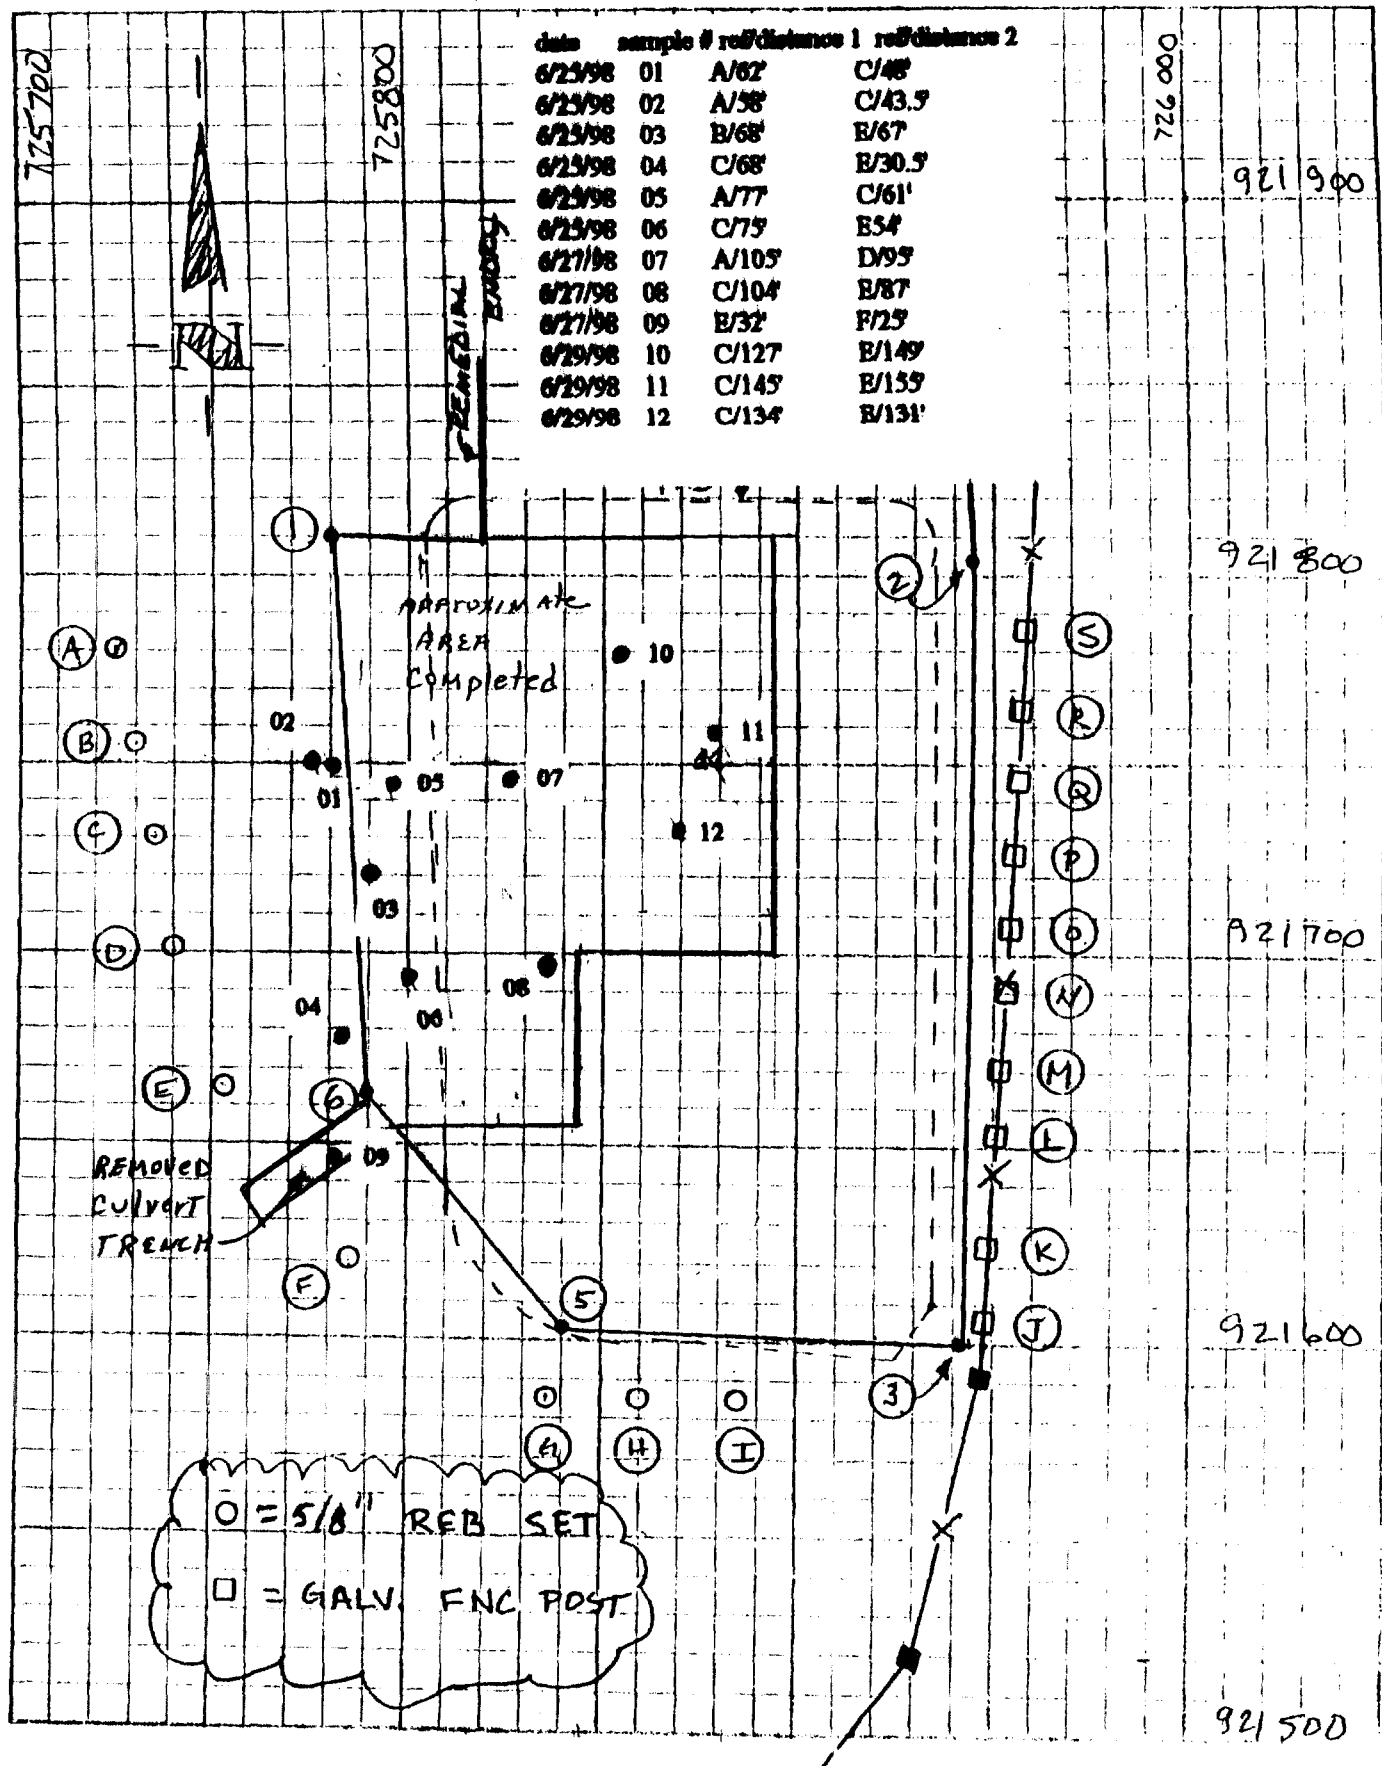
PROJECT NAME: ENVIROCHEM @ NSL
PROJECT PHASE:
DESCRIPTION: REF PTS FOR SAMPLING

PROJECT NO: 799.003 SHEET 2 OF 2
DESIGNED BY: N. CRIDUN
CHECKED BY: B. HULL
DATE: 13 JUN 98
ASSUMPTIONS / REFERENCES:
